To:Cutting Module Design TeamsFrom:Ralph Stirling, Manufacturing EngineerSubject:Analysis of 2001 Model Slot Cutting MachineDate:2003-04-13

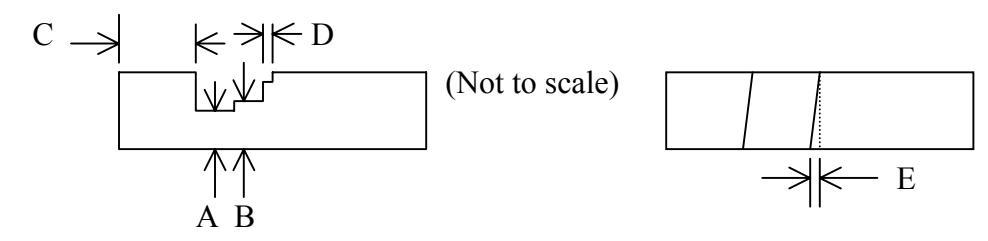
Part measurements:

- Angle error E was approximately 0.01", giving an angular error of about 0.76° (comparing with dial caliper by eye).
- First-pass to second-pass cutting offset D was approximately 0.005" (again comparing with dial caliper by eye)
- Both router full-depth cutting passes sloped by about .005", and had an offset between slots that varied from 0.000 to 0.0045".
